### NASA TN D-3456

PROJECTILE-IMPACT-INDUCED FRACTURE OF LIQUID-FILLED, FILAMENT-REINFORCED PLASTIC OR ALUMINUM TANKS

by Francis S. Stepka Lewis Research Center Cleveland, Ohio

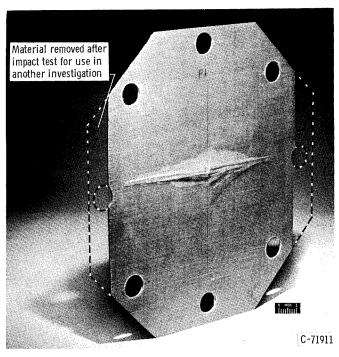
mens (tests 1 and 2, respectively, table I) resulted in only a penetration of the specimens and delaminations of the outer filament layer of the specimens in the vicinity of the impact. The results of the impact into the 0.125-inch-thick specimen are shown in figure 4. Before a photograph of the complete specimen was made, a portion of the specimen material had been removed after the impact for use in another investigation. An outline of the portion removed is shown with dashed lines.

Figure 4. - Impact into unstressed 0.125-inch-thick glass-reinforced epoxy specimen wall on water-filled tank (test 1). Impacting projectile, 7/32-inch-diameter aluminum sphere; velocity, 6500 feet per second.

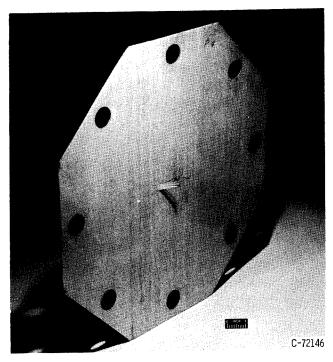
Because no fracturing of the initially unstressed specimens was obtained, impacts were initiated into stressed specimens. Impact into a 0.063-inch-thick sheet specimen of a Dacron-filament-reinforced urethane pressurized to 50 pounds per square inch gage (initial static membrane stress, about 3900 psi) also resulted in only a penetration and delamination of the outer fibers.

Figure 5. - Impact into 0.063-inch-thick Dacron-reinforced urethane specimen wall on liquid-nitrogen-filled tank pressurized to 50 pounds per square inch gage (test 4). Impacting projectile, 7/32-inch-diameter steel sphere; velocity, 5500 feet per second.

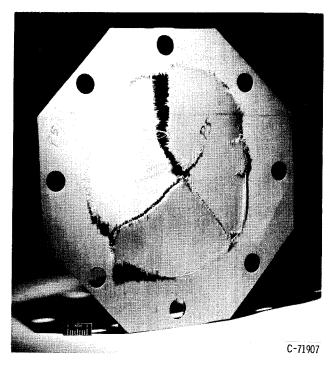
Dacron-filament-reinforced urethane specimens: An impact made with a 7/32-inch-diameter steel sphere at a velocity of about 5500 feet per second into a 0.063-inch-thick sheet specimen of Dacron-reinforced urethane pressurized to 50 pounds per square inch gage (wall stress, about 8000 psi) resulted in a puncture and a local delamination of the outer filament layer (test 4), as shown in figure 5. When the initial stress before impact in two other Dacron-reinforced specimens (tests 5 and 6) was increased to about 12 800 pounds per square inch (by a liquid pressure of 100 psig), impact by a projectile resulted in catastrophic fracturing of the specimens, as shown in figure 6 for test 5.

Figure 6. - Impact into 0.063-inch-thick Dacron-reinforced urethane specimen wall on liquid-nitrogen-filled tank pressurized to 100 pounds per square inch gage (test 5). Impacting projectile, 7/32-inch-diameter steel sphere; velocity, 5500 feet per second.

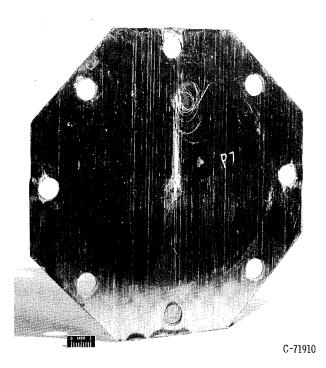
0.032-inch-thick sheets of steel-wirereinforced urethane (tests 7 to 9) resulted in only a hole and local delaminations of the outer layer of the wire in the vicinity of the hole. Prior to impact, these specimens were pressurized internally to values of 100 to 175 pounds per square inch gage. which resulted in wall stresses of 28 500 to 30 000 pounds per square inch, respectively. Impact into the remaining specimen with a 0.032-inch-thick wall that was pressurized to 175 pounds per square inch gage (test 10) resulted in large areas in which the wire layers were delaminated. The results of impact into two of these specimens (tests 7 and 10) are shown in figure 7 and 8, respectively.

Figure 7. - Impact into 0.032-inch-thick steel-wire-reinforced urethane specimen wall on liquid-nitrogen-filled tank pressurized to 100 pounds per square inch gage (test 7). Impacting projectile, 7/32-inch-diameter steel sphere; velocity, 5500 feet per second.

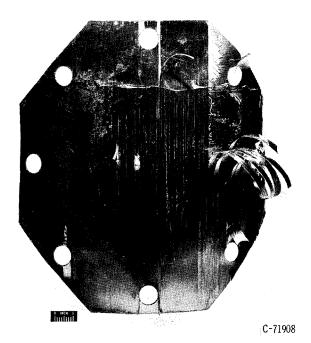
Figure 8. - Impact into 0.032-inch-thick steel-wire-reinforced urethane specimen wall on liquid-nitrogen-filled tank pressurized to 175 pounds per square inch gage (test 10). Impacting projectile, 7/32-inch-diameter steel sphere; velocity, 5500 feet per second.

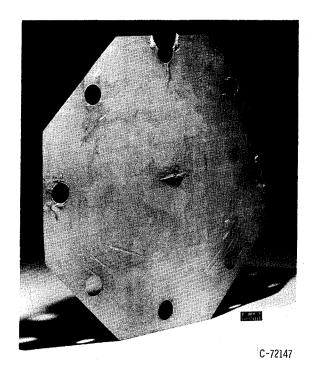
to 0.023-inch thickness (tests 11 to 13) that were impacted after the wall had been initially stressed to levels of 26 700 to 39 800 pounds per square inch (liquid pressures 50 to 125 psig) resulted in only a hole and local delamination of the outer filament layer. Impact into a specimen 0.023 inch thick and pressurized to 175 pounds per square inch gage to induce a wall stress of about 43 500 pounds per square inch (test 14) resulted in local delamination of the outer filament layer and a tearing of the wall extending about 3/4 inch from the edge of the hole (fig. 9). Further testing of the sheet specimens at higher stress levels was impossible because of yielding in the specimen material surrounding the bolt holes.

Figure 9. - Impact into 0.023-inch-thick glass-reinforced epoxy specimen wall on liquid-nitrogen-filled tank pressurized to 150 pounds per square inch gage (test 14). Impacting projectile; 7/32-inch-diameter steel sphere; velocity, 5500 feet per second.

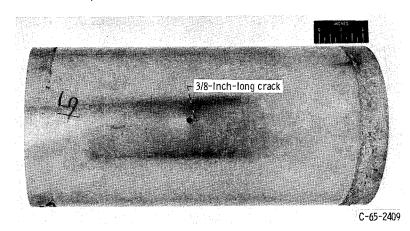
Impacts into one of the tanks with a 0.032-inch wall thickness with an initial static tank wall-stress - ultimate-strength ratio of 0.1 (test 24) resulted in a catastrophic bursting (fig. 11(a)). The result of impact into the same thickness tank without any initial pressurization (test 25) resulted in a hole and a small crack (about 3/8-in. long) at the edge of the hole (fig. 11(b)). Impacts into the tank with a 0.063-inch-thick wall stressed to 30 percent of the material ultimate strength prior to impact (test 26) and into the two tanks with the 0.081-inch wall thickness stressed to 33 and 50 percent of the material ultimate strength (tests 27 and 28) resulted only in holes in the tank walls. Increasing the wall stress to 58 percent of the ultimate for the tank with the 0.084-inch-thick wall (test 29) resulted in catastrophic bursting of the wall as a result of projectile impact.

(a) Tank pressurized to 10 percent of ultimate stress before impact (test 24).

(b) Tank without any initial pressurization prior to impact (test 25).

Figure 11. - Results of impact into 0.032-inch-thick, 7.5-inch-diameter 2014-T6 aluminum tanks filled with liquid nitrogen. Impacting projectile, 7/32-inch-diameter steel spheres; velocity, 5500 feet per second.
